System Failure Case Studies

Volume 1 Issue 3

ALMOST PERFECT

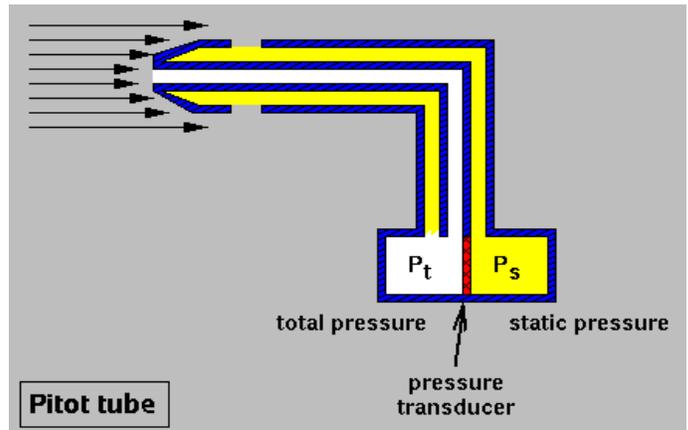
The Mishap Investigation Board found that "The [Pitot tube] icing led to incorrect total air pressure data being sent to the flight control computers (FCC) by the Pitot-static system. This resulted in the aircraft becoming unstable as it accelerated and descended to return for landing."

The Pitot tube measures air speed by evaluating the difference between the static air pressure and the total air pressure induced by the airflow.

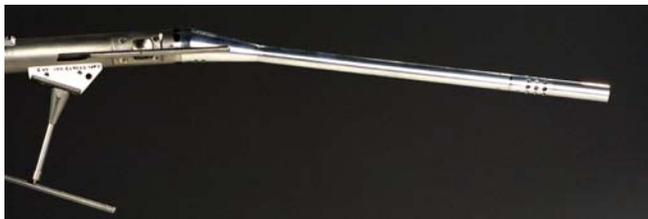
The Kiel probe design angled the Pitot tube 10 degrees from the centerline of the aircraft. This design enabled more accurate air speed indication at high angles of attack.

When the Kiel probe was installed, it was not equipped with Pitot heat. (The Rosemount probe had included Pitot heat.) This change introduced two factors that increased the risk of icing on the Pitot tube: 1) the design of the Kiel probe is inherently more prone to icing and 2) the Kiel probe did not have heat.
