Almost Perfect: X-31 Mishap

Leadership ViTS Meeting
August 2007

Bryan O'Connor
Chief, Safety and Mission Assurance

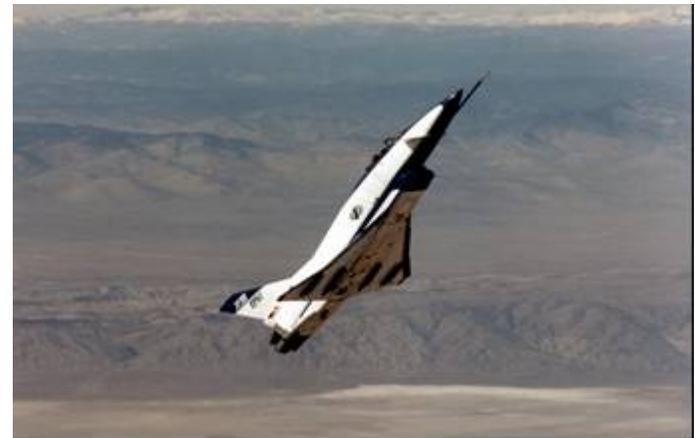
- On January 19, 1995, during a routine flight test, the X-31's flight control computers (FCC) began registering errors in flight data about 20 minutes after take-off.
- Unbeknownst to the pilot and control room, ice was accumulating and blocking air flow around the 'Pitot tube,' (a device used for measuring air speed).
- Later in the flight, the pilot noticed further errors in airspeed indication, prompting him to notify the control room and turn on the Pitot heat.
- The control room notified the pilot that the Pitot heat might not be hooked up.
- After receiving this message, the aircraft began to oscillate out of control and then violently pitched upward.
- The pilot ejected before the aircraft departed into a spin and impacted the ground.

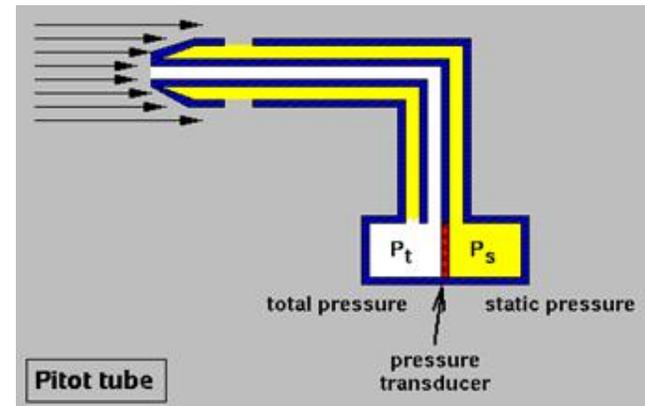
- Air speed for the X-31 (and most conventional aircraft) is calculated based on inputs from a device called a Pitot tube.
- Pitot tubes are susceptible to accumulation of ice which causes them to malfunction.
- Accurate airspeed measurements were especially critical to the X-31's FCCs which were responsible for vectoring thrust to keep the aircraft stable and on course.
- In the original X-31 design, the Pitot tube was mounted on a "Rosemount probe" which had a heater to prevent Pitot tube icing.
- To improve performance, the Rosemount probe was replaced with a Keil probe which did not have a heater.

- Pitot tube icing caused incorrect total air pressure data to be sent to the FCCs by the Pitot-static system.
