Supercritical: SL-1 Nuclear Reactor Explosion

Leadership ViTS Meeting
September 2007

Bryan O'Connor
Chief, Safety and Mission Assurance

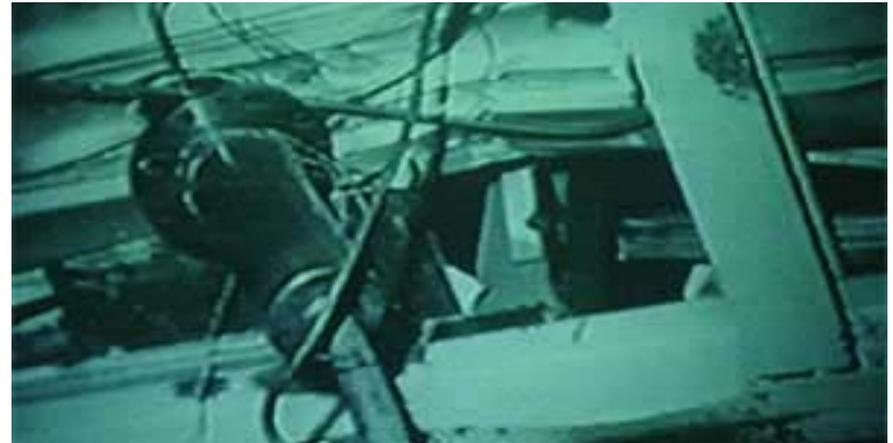
- In January of 1961, the SL-1 nuclear reactor exploded near Idaho Falls, Idaho, killing three engineering technicians on duty.
- While performing a basic maintenance procedure – attaching the control rods to the control rod drive mechanism – a technician lifted the central control rod to a height of 20 inches in 0.5 seconds.
- This withdrawal caused the reactor to go “supercritical” in just 4 milliseconds as the core power level surged to 20,000 megawatts or over 6,000 times the rated power output.

Control rod lodged in the ceiling of the SL-1 Reactor building

- The heat generated by the power surge vaporized the water, hammering steam into the top of the reactor and causing it to lift nine feet off the ground.

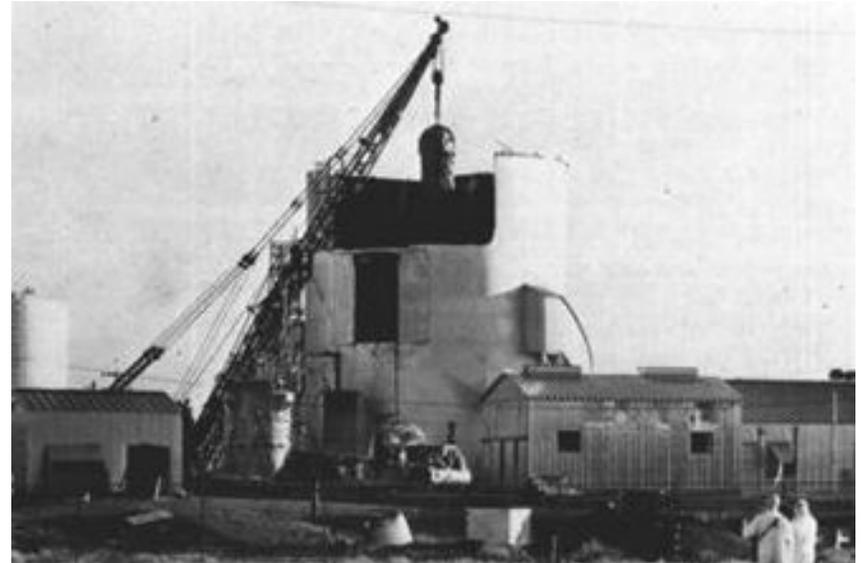
Reactor being lifted from the National Reactor Testing Station
