APRIL 2015 VOLUME 8 ISSUE 4

Deadly Exposure

The West Virginia DuPont Phosgene Release

SYSTEM FAILURE CASE STUDY

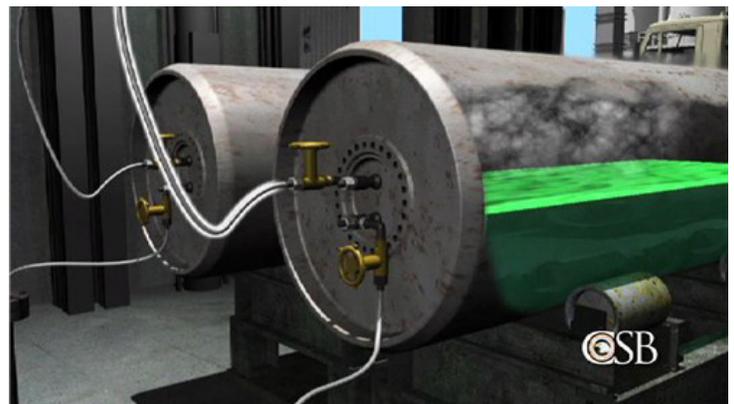
On Saturday, January 23, 2010, at approximately 1:45 p.m. local time, a phosgene transfer hose connected to a partially filled cylinder burst as an operator was inside the phosgene shed. The operator was checking the status of the cylinders in anticipation of a transfer and was not wearing enhanced PPE. The operator was sprayed across the chest and face as 2 pounds of phosgene inside the hose leaked into the atmosphere. The liquid phosgene had remained in the hose from a previous transfer operation.

Figure 2. Artist's rendition of the two-tank setup inside the phosgene shed at DuPont Belle. Source: CSB

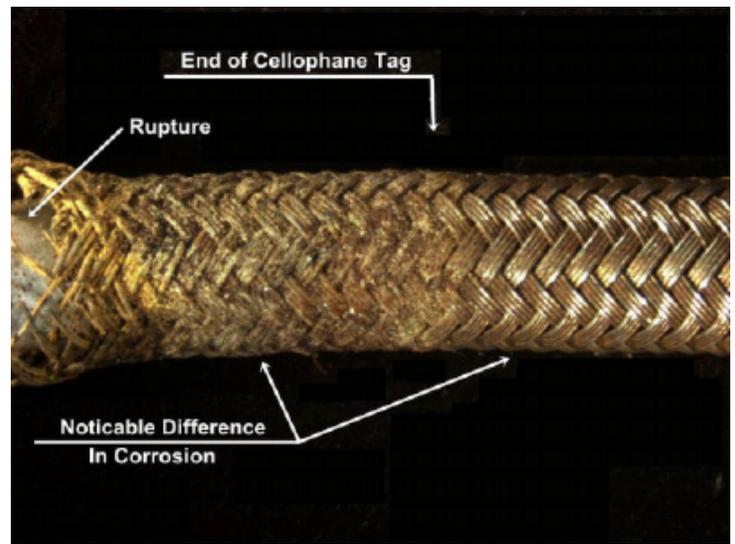
CSB investigators found that the majority of tags attached to the hoses to indicate their intended service were secured in place with plastic ties and metal clamps. However, the manufacturer's tag on the hoses was secured with white plastic adhesive tape. Extensive corrosion was localized under the area covered by the tape. The permeable PTFE and braided 304 stainless steel of the hoses had provided an ideal environment under the tape for phosgene vapor to collect and convert to hydrogen chloride (HCl), which then caused stress corrosion cracking (SCC). Although questions were raised concerning whether or not the hoses used were the ideal choice for phosgene transfer, DuPont previously calculated the risk and cost-effectiveness of purchasing replacement hoses to be too high.

At the time of the incident, the isolation valves for the phosgene hose were closed, and the hose retained liquid phosgene between the valves. Corrosion weakened the hose braiding over time, allowing thermal expansion of the isolated liquid phosgene until the hose failed. Although Process Hazard Analyses (PHAs) occurred at the Belle plant in 1994, 1999, 2004, and 2009, the analysis for the phosgene system only included the 1-ton cylinders, nitrogen pressuring system, vaporizer, and all associated piping and controls. While DuPont assessed the potential for a phosgene leak if the hoses were incorrectly connected or inadvertently disconnected while the feed valve was open, they did not assess the potential for the hose to rupture due to thermal expansion. However, the potential for liquid phosgene thermal expansion was evaluated in other process equipment during the 2009 PHA.

Although the maintenance plan for the hoses prescribed a regular change-out schedule of 30 days, work orders show that change-out frequency was neither systematic nor predictable. Between 2006 and 2010, hoses were left in service from 4 to 7 months multiple times. The hose that failed on January 23, 2010 had been in use for over six months. This period included a plant-

Figure 3. The corroded and ruptured PTFE stainless steel hose from the DuPont Belle phosgene leak. Source: CSB

The CSB also recommended that the Belle plant revise their emergency response protocol to require that a responsible and accountable employee be available at all times to provide timely and accurate information to emergency dispatchers. They also recommended that DuPont prohibit the use of hoses with permeable cores and materials susceptible to chlorides corrosion for phosgene transfer. Acceptable corrective action can be found on the CSB website for the incident.
