NASA SAFETY CENTER SYSTEM FAILURE CASE STUDY

No Guarantees

The Gulfstream G650 Test Crash

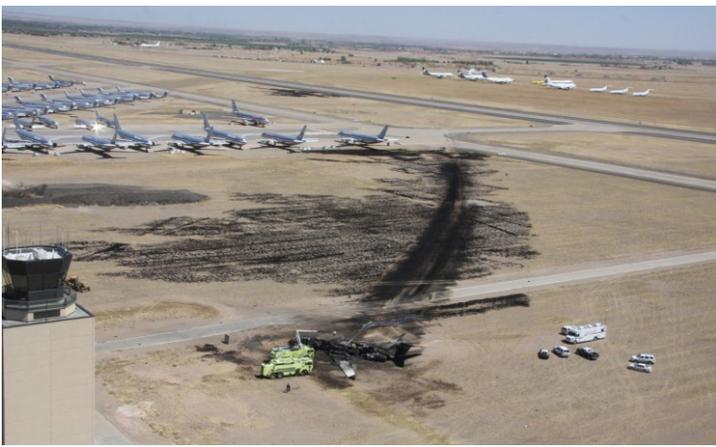
Figure 1. The wreckage of the Gulfstream G650 involved in the incident. Source: NTSB

On April 2, during the twelfth takeoff of the day, the pilot abruptly raised the aircraft's nose 11.2 degrees — 2.2 degrees past the target pitch angle of 9 degrees — while using the modified piloting technique. The right outboard wing stalled and the aircraft rolled right. The right wingtip struck the runway and the aircraft departed the runway to the right. It then struck a concrete structure and airport weather station. The aircraft crashed 8,404 feet from the runway and the ensuing fire consumed the fuselage and cabin interior. The two pilots and two flight test engineers aboard died.

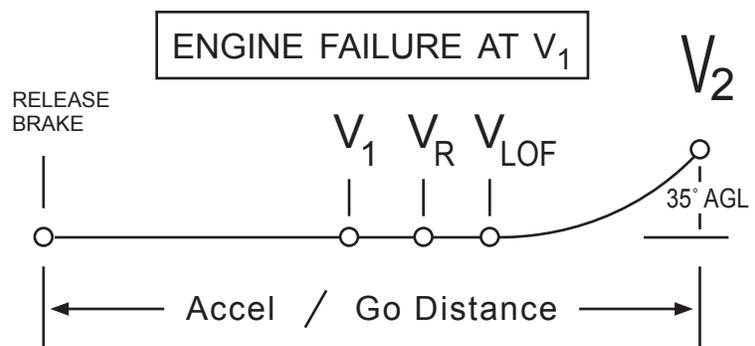
The G650 consistently exceeded target V2 takeoff safety speeds — or the speed that an airplane attains at or before a height of 35 feet Above Ground Level (AGL) with one engine inoperative. Gulfstream needed to resolve these V2 exceedances because achieving the planned V2 speeds was necessary to maintain the airplane's 6,000-foot takeoff performance guarantee. Otherwise, the airplane could only operate on longer runways.

Figure 2. V1 indicates the speed beyond which the takeoff should no longer be aborted. VR indicates the speed at which the pilot begins to apply control inputs to cause the aircraft nose to pitch up, after which it will leave the ground. VLOF indicates lift-off speed. V2 indicates takeoff safety speed—the speed at which the aircraft may safely be climbed with one engine inoperative. One engine of the G650 was stalled in order to validate the V2 speed. Source: NASA

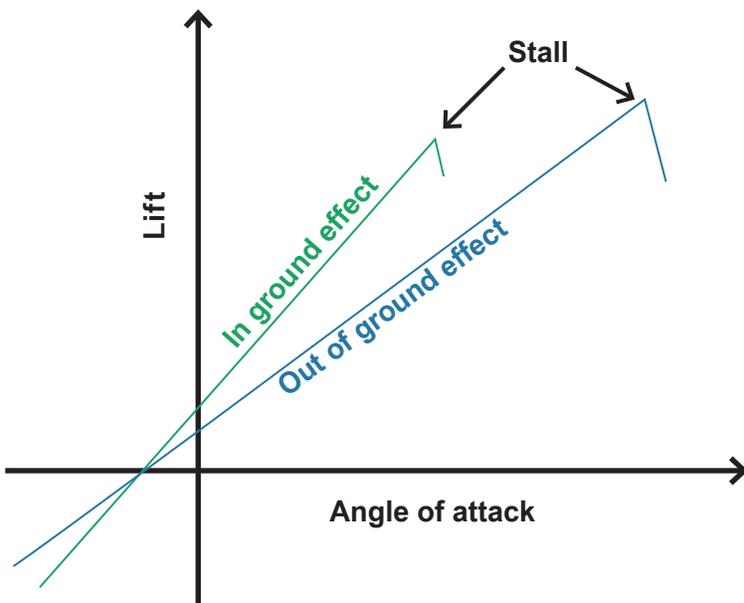
The NTSB also examined the role of “ground effect” on the airplane’s performance. Ground effect refers to changes in the airflow over the airplane resulting from the proximity of the airplane to the ground. Ground effect results in increased lift and reduced drag at a given angle of attack (AOA) as well as a reduction in the stall AOA. In preparing for the G650 field performance flight tests, Gulfstream considered ground effect when predicting the airplane’s takeoff performance capability but overestimated the in-ground-effect stall AOA. Consequently, the airplane’s AOA threshold for stick shaker (stall warning) activation and the corresponding pitch limit indicator (on the primary flight display) were set too high, and the flight crew received no tactile or visual warning before the actual stall occurred.

As pitch angle and AOA were increasing through 11.2 degrees, large aerodynamic rolling and yawing moments to the right were acting on the airplane. These aerodynamic moments were indicators of an asymmetric stall of the airplane. Before the accident, Gulfstream estimated that the in-ground-effect stall AOA would be 13.1 degrees and set the AOA threshold for the activation of the stick shaker stall warning at 12.3 degrees.

Figure 3. Aircraft lift versus angle of attack in and out of ground effect. Source: NTSB
