# System Failure Case Studies

## THE MILLION MILE RESCUE

*The Solar Heliospheric Observatory spacecraft (SOHO) is a major element of the joint ESA/NASA International Solar Terrestrial Program. It was launched on December 2, 1995, and successfully completed its primary mission by 1997. After implementation of code modifications meant to increase SOHO's lifetime during its extended operations phase, multiple errors in the new command sequences repeatedly sent the spacecraft into an emergency safe mode. One key error remained undetected while ground controllers made a critical mistake based on an unconfirmed and faulty assumption. SOHO's attitude progressively destabilized until all communication was lost in the early hours of June 25, 1998. It took three months to miraculously recover and restore SOHO to full mission status.*

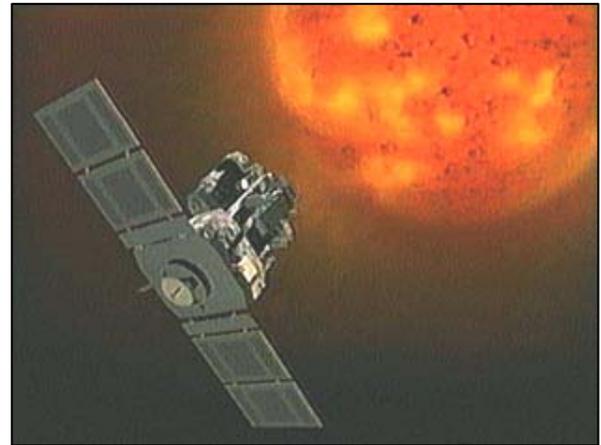
**Figure 1:** Artist's conception of the SOHO spacecraft.

The Solar Heliospheric Observatory (SOHO) is a joint international project between NASA and the European Space Agency (ESA) to study the Sun, from its deep core to the outer corona, and the solar winds, using 12 on-board scientific instruments (Figure 1). Launched on December 2, 1995, SOHO was designed for a two year mission. But in 1997, the mission was extended to 2003 because of its spectacular success. This extension was the basis of the code modification that sparked this mishap. After recovery, subsequent extensions were granted through 2009.

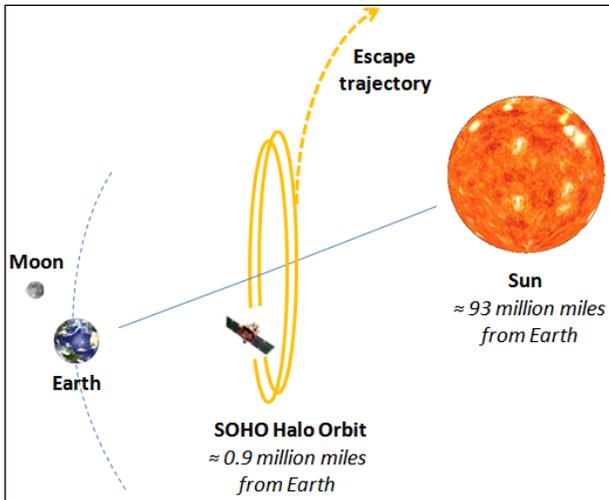
**Figure 2:** SOHO’s halo orbit is about four times the distance away from Earth as the Moon. Escape trajectory is also shown. Schematic is not to scale.

SOHO was designed to revolve around the Sun in lock step with the Earth's own revolution (Figure 2) by maintaining a halo orbit around the First Lagrangian point, where the combined gravity of the Earth and the Sun keep SOHO's orbit anchored in the Earth-Sun line. Once in this orbit, SOHO's attitude was generally stable and used spinning reaction wheels controlled by an Attitude Control Unit (ACU) computer to autonomously adjust for internal or external disturbance torques. If the wheels reached a spin near their design limit, ACU automatically despun the wheels, used thrusters to stabilize attitude, and then reactivated the wheels to resume attitude control. The ACU used a gyroscope (Gyro C) to sense roll attitude during these maneuvers.

by mid-November, it would diverge and escape into a solar orbit (Figure 2). By a stroke of good fortune, calculations also indicated that in roughly 90 days the spin of the spacecraft would naturally align the solar arrays with the Sun for about half of a spin period, giving the recovery team the opportunity to regain control over SOHO within the time window. On July 23, combining the Arecibo radio telescope in Puerto Rico with NASA's Deep Space Network in California the team was able to locate the spacecraft's radar echoes and confirm both its location and spin rate.
