Deadly Exposure: The West Virginia DuPont Phosgene Release

Steve Lilley

04/14/2015

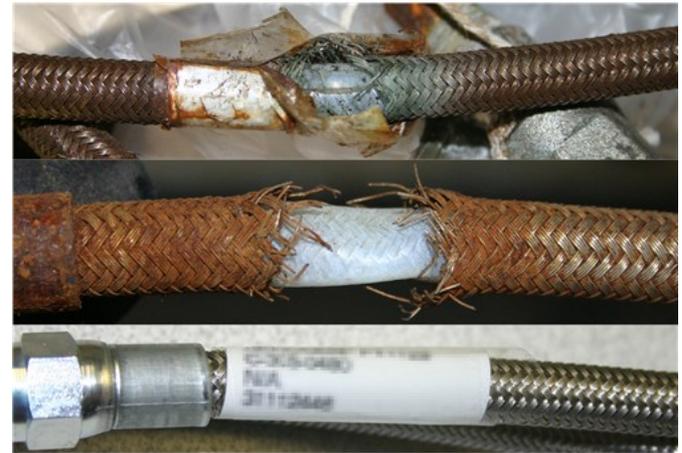
- U.S. Chemical Safety Board (CSB) investigators found that the manufacturer's tag was secured to the hose with white plastic adhesive tape. Extensive corrosion was localized under the area covered by the tape. The permeable PTFE and braided stainless steel provided an ideal environment under the tape for vapor from liquid phosgene retained in the hose between the valves to collect and convert to hydrogen chloride and caused stress corrosion cracking.

Varies corroded PTFE stainless steel braided hoses at DuPont Belle. Source: CSB

- The hose that failed on January 23, 2010 had been in use for over six months, in violation of the plant's original 30-day change-out schedule. DuPont did not provide a back-up method to ensure timely change-out and the maintenance software was not documented or reviewed in accordance with Management of Change (MOC) processes.

- On the morning of the incident, maintenance personnel replaced the phosgene hose on the phosgene tank not involved with the incident because of a suspected flow restriction. As the hose and valve assembly was decontaminated in a water bath, the adhesive tag fell off and revealed a corroded section of the stainless steel braid and collapsed PTFE liner.

- The CSB outlined recommendations for Belle that involve improving the existing maintenance management program by supplementing the computerized system with sufficient redundancies and conducting MOC reviews for all changes to preventative maintenance orders for all Process Safety Management-critical equipment in the computerized maintenance management system. Additionally, revisions were suggested for the near-miss reporting system and investigation policy so that it is operational at all times.
