NASA SAFETY CENTER SYSTEM FAILURE CASE STUDY

MARCH 2015 VOLUME 8 ISSUE 3

All Shook Up

The LADEE Spacecraft Vibration Mishap

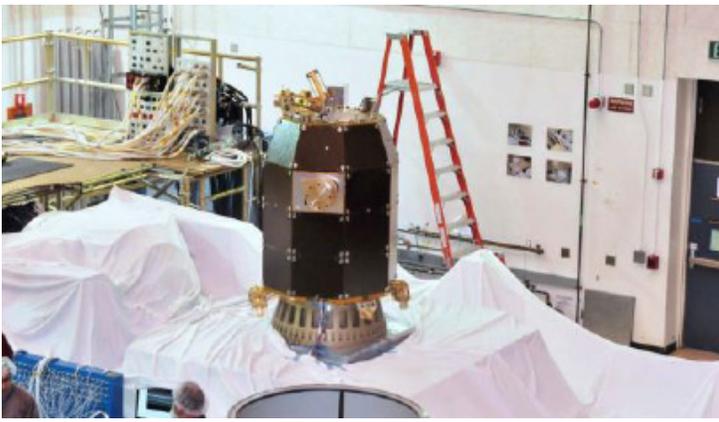
Figure 1. The LADEE spacecraft ETU on the vibration sliptable. Source: NASA

On Thursday, May 3, 2012, the LADEE spacecraft ETU (Figure 1.) was fully configured for testing and was securely mounted on the vibration shaker sliptable. The entire test system consisted of a shaker (with a 65,000-pound force peak sine force and a 2-inch stroke), amplifier, and sliptable, coupled to a control system. The system was successfully demonstrated weeks prior on April 17, 2012 with a non-representative test article simulator at sine burst levels of 16 Hz and 9.4 g's to envelope the loads being finalized for the LADEE tests.

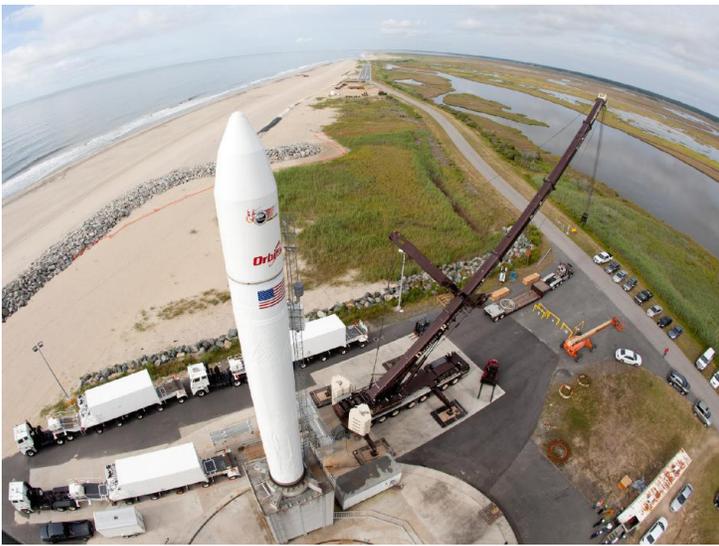
Figure 4. An Orbital Sciences Corporation Minotaur V expendable launch system. Derived from the land-based LGM-118A Peacekeeper ICBM, its maiden flight carried the LADEE spacecraft payload. Source: NASA
