NASA SAFETY CENTER  
SYSTEM FAILURE CASE STUDY

# Asynchronicity

## The Near Loss of the Apollo-Soyuz Test Project Crew

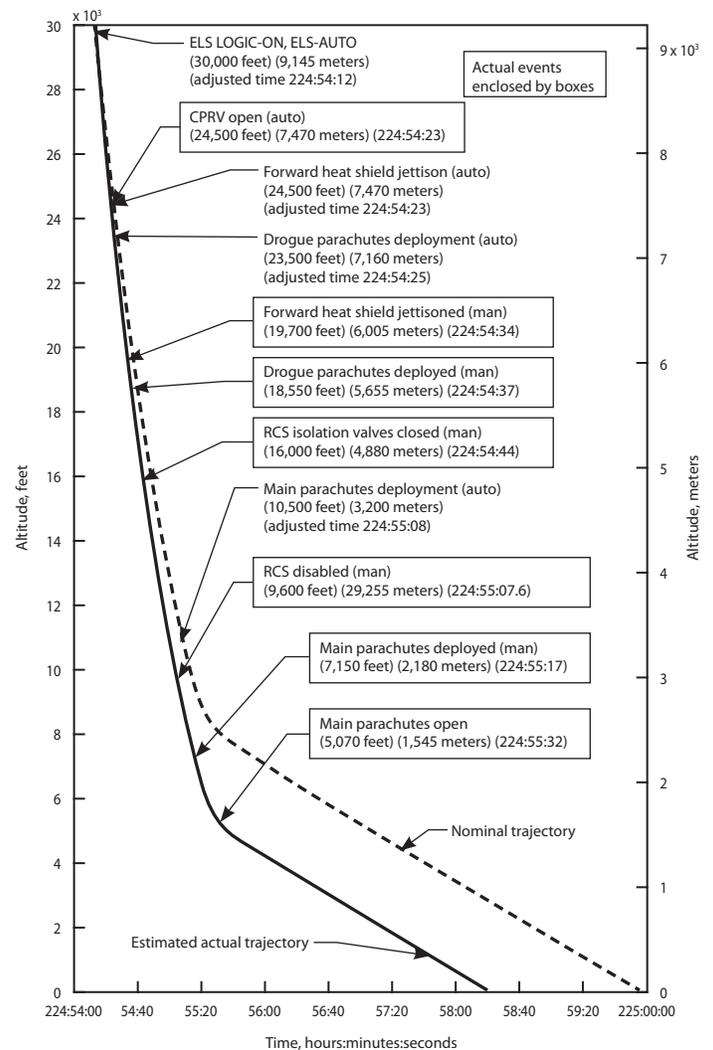
Figure 2. Comparison of actual and nominal ASTP descent sequences. Source: NASA

However, during the actual descent, the Command Module Pilot (CMP) armed the ELS pyrotechnic buses approximately 20 seconds late at 37,000 feet. Falling behind the time-critical descent profile, the CDR read the checklist, but the CMP did not acknowledge or arm the two automatic ELS sequencer switches when the Docking Module Pilot (DMP) called them out at 30,000 feet.

As the CM hurtled from 30,000 feet to 24,000 feet, the CDR stated the altitude and realized that the drogue parachutes had not deployed automatically. The DMP said, "Hit your button there." The CMP immediately pushed the guarded APEX COVER JETT pushbutton and then the DROGUE DEPLOY, which jettisoned the apex cover and deployed the drogues at 19,700 feet and 18,550 feet, respectively. At approximately 16,000 feet, the CDR stated he had the CM Propellants

OFF (RCS isolation valves closed). However, the RCS was still enabled because the automatic ELS function had not been armed, and the manual RCS Command (CMD) switch had not been thrown to OFF. The CDR then realized the ELS was not in AUTO and switched LOGIC and AUTO (RCS commands disabled) at 9,600 feet and deployed the main parachutes at 7,150 feet.

1. Spacecraft control was not returned to the proper mode at 90,000 feet.
2. The pyrotechnic buses were not armed at 50,000 feet.
3. The RCS was not disabled "RCS CMD-OFF" at 24,000 feet.
4. The two switches that arm the ELS sequencer were thrown 55 seconds after the intended 30,000-foot mark.

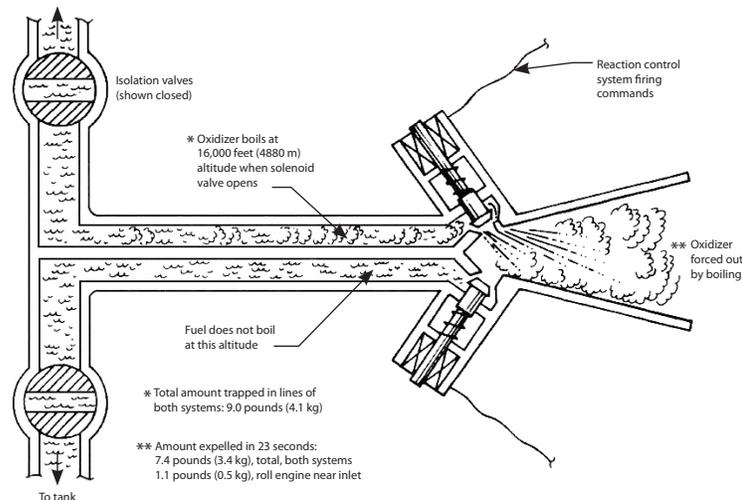
Figure 3. The ASTP oxidizer boiloff process. Source: NASA

During the 30-second period of high RCS thruster activity,  $N_2O_4$  oxidizer was expelled from the thrusters for a period of seven seconds. Then, when the CDR closed off the propellant isolation valves, the oxidizer — trapped between the isolation valves and the thruster solenoid valves — began to boil off as the thrusters operated for another 23 seconds (before the RCS was inhibited by the RCS disable relay).

The cabin pressure relief valve opened automatically at 24,500 feet to allow outside air to vent into the cabin to equalize cabin pressure with ambient atmospheric pressure. The valve was located two feet downwind of the firing end of one of the positive RCS roll thrusters. Designers had not addressed the potential for the valve to open with the thruster still firing.

$N_2O_4$  reacts with air to form a variety of nitrogen oxides, principally nitrogen dioxide,  $NO_2$ . Although  $N_2O_4$  and  $NO_2$  gases are colorless, the intermediate state of nitrogen trioxide,  $N_2O_3$ , varies from yellow to reddish-brown as air concentrations increase. The CDR stated that he observed a dark reddish-brown cloud suddenly occupying his entire field of view lasting between 20 to 30 seconds and containing

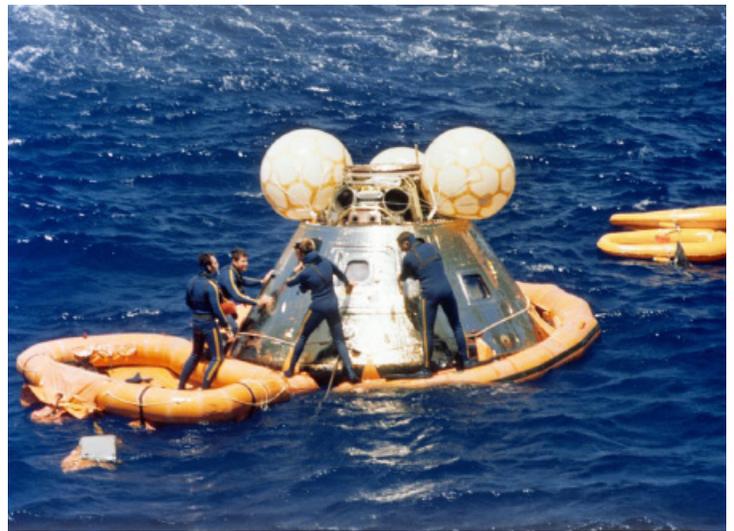
Figure 4. The uprighted ASTP CM during recovery in the Pacific Ocean. Source: NASA

Upon splashdown, the CM flipped over, suspending the three crewmen upside down in their harnesses. The CMP hung unconscious and the others coughed while the CDR freed himself to retrieve their emergency oxygen masks, which had been stowed and were inaccessible during descent. The crew donned masks, and after regaining his senses, the CMP actuated the spacecraft's uprighting system.
