Lithium Ion Battery Safety

How Agencies and DoD Assess and Mitigate Hazards

SAFETY & HEALTH
LEARNING ALLIANCE

787 incident at Boston, January 7, 2013

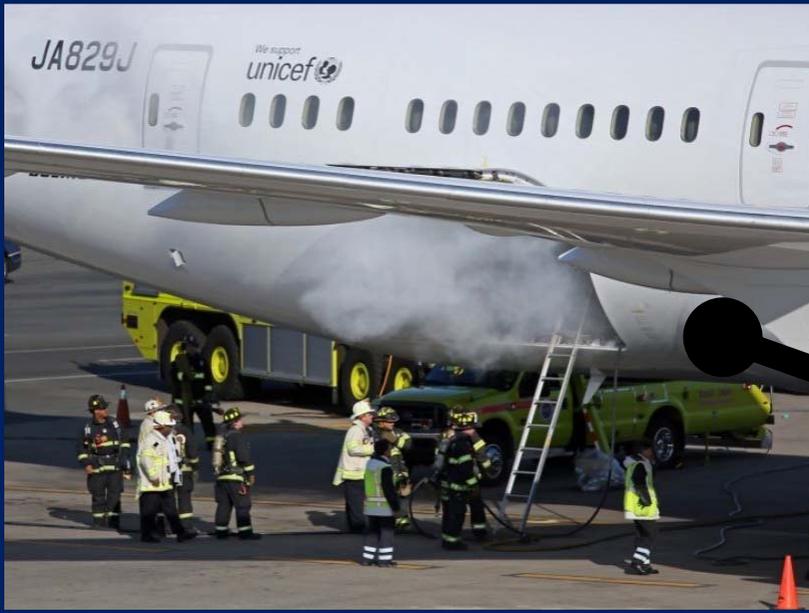
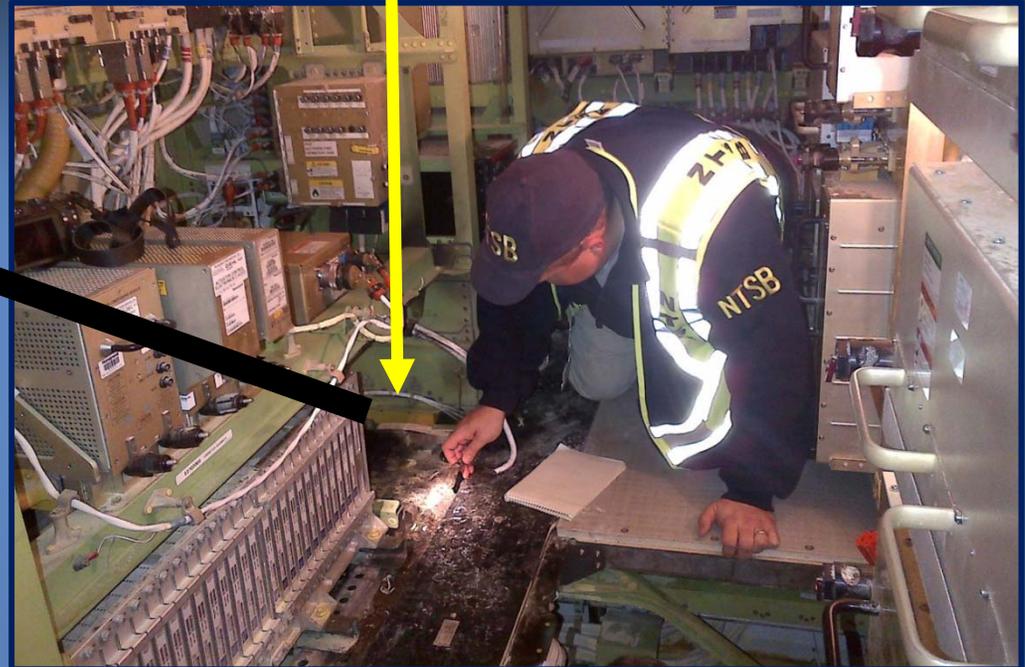
APU battery removed from here

14 Months after 787 intro to airline use
3 Weeks after airplane delivery
Airplane on ground with APU power
Cleaning crew, mechanic, manager
Smoke event for about 45 minutes.
Minor burn to one firefighter.
Normal access through floor

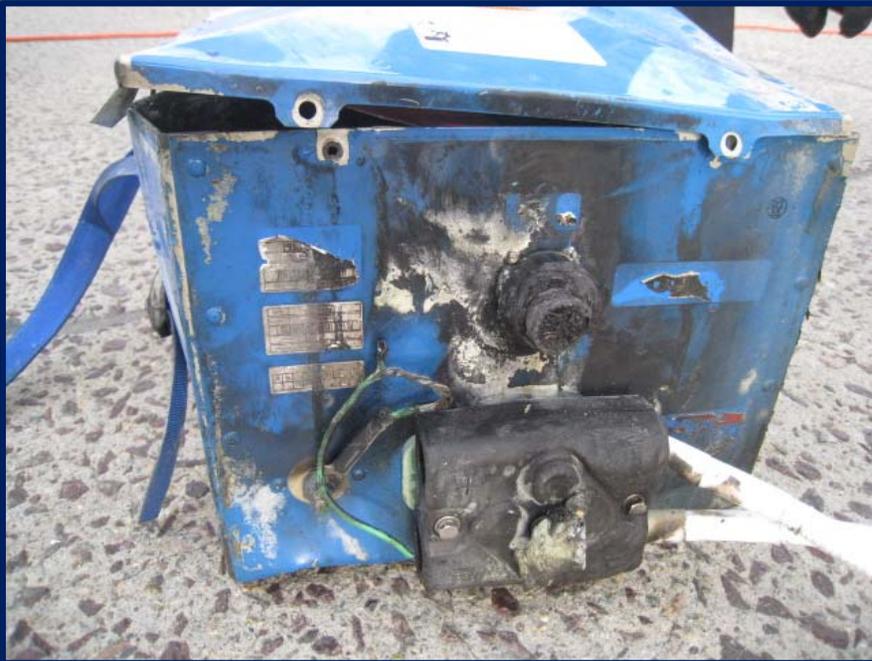
External Case Damage

Burned connectors at front of case

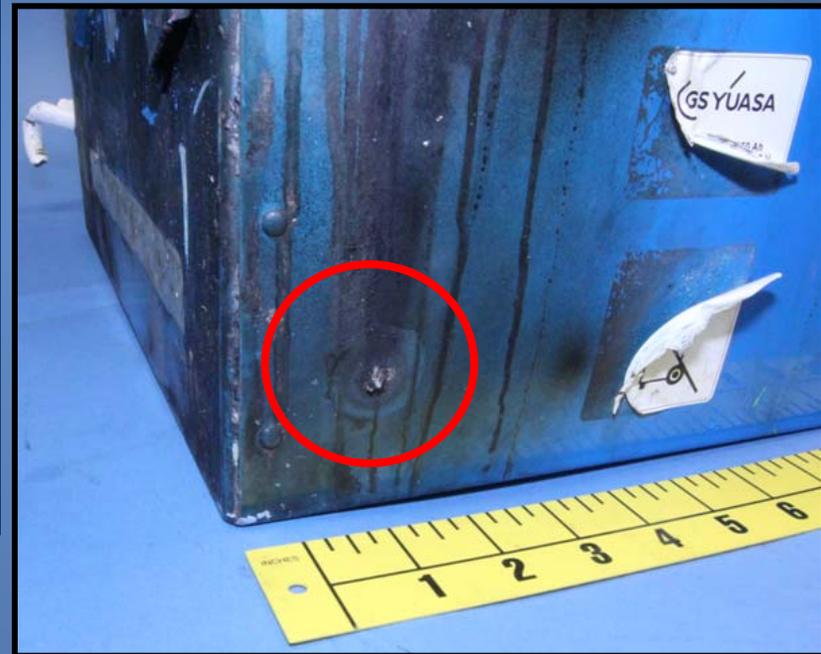
“Protrusion” melting at back of case

Sketch by mechanic who saw flame

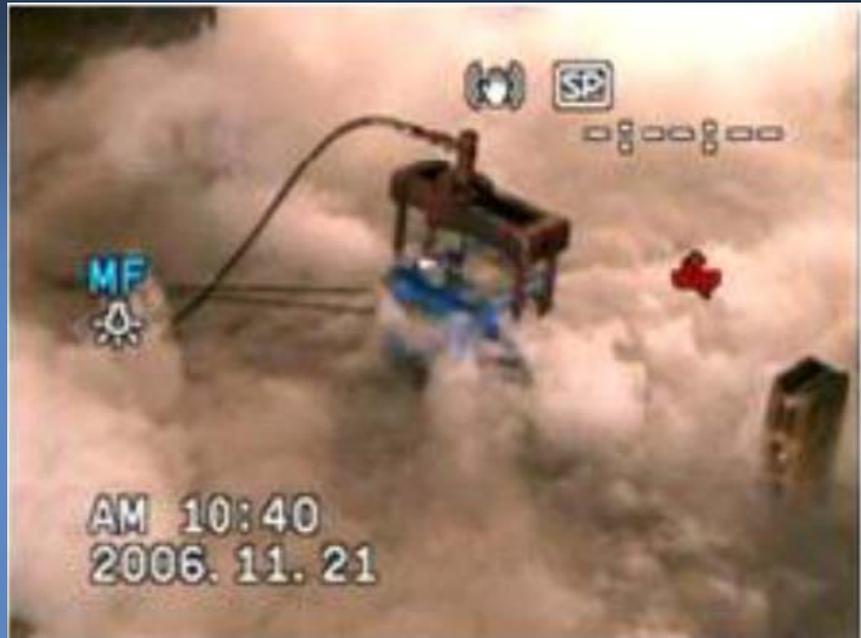
2006 GS-Yuasa test

Release of electrolyte and smoke

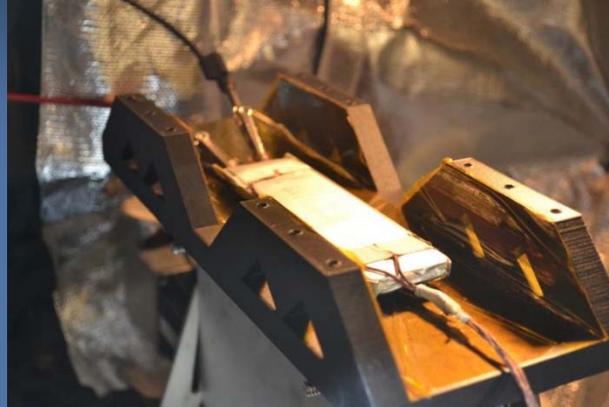
Laser Ignition As An Abuse/ISC Method

Sandia Lab Proof of concept by Lamb, Steele, Orendorff in presentation to Battery Safety Council January 12, 2017

Single cell failure initiated using 40W pulse laser
~40 J total energy needed for failure (20 pulses)

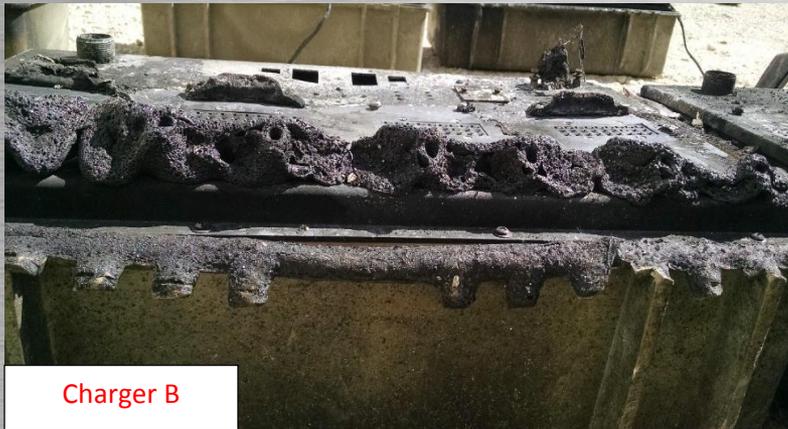
Charger B

- **Rear views** of the chargers.
 - Damage indicates fire started where they met

Damage decreases

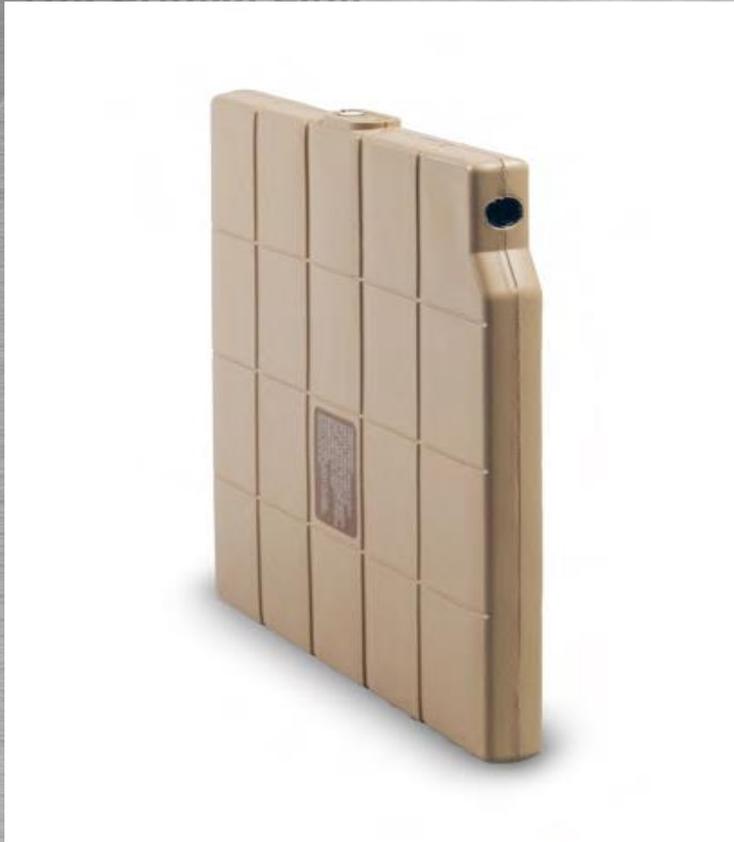
Conformal Wearable Batteries (CWB) An Exemplar CWB

Approximate Parameters
(Varies by capacity/end use)

85Wh to 185 Wh

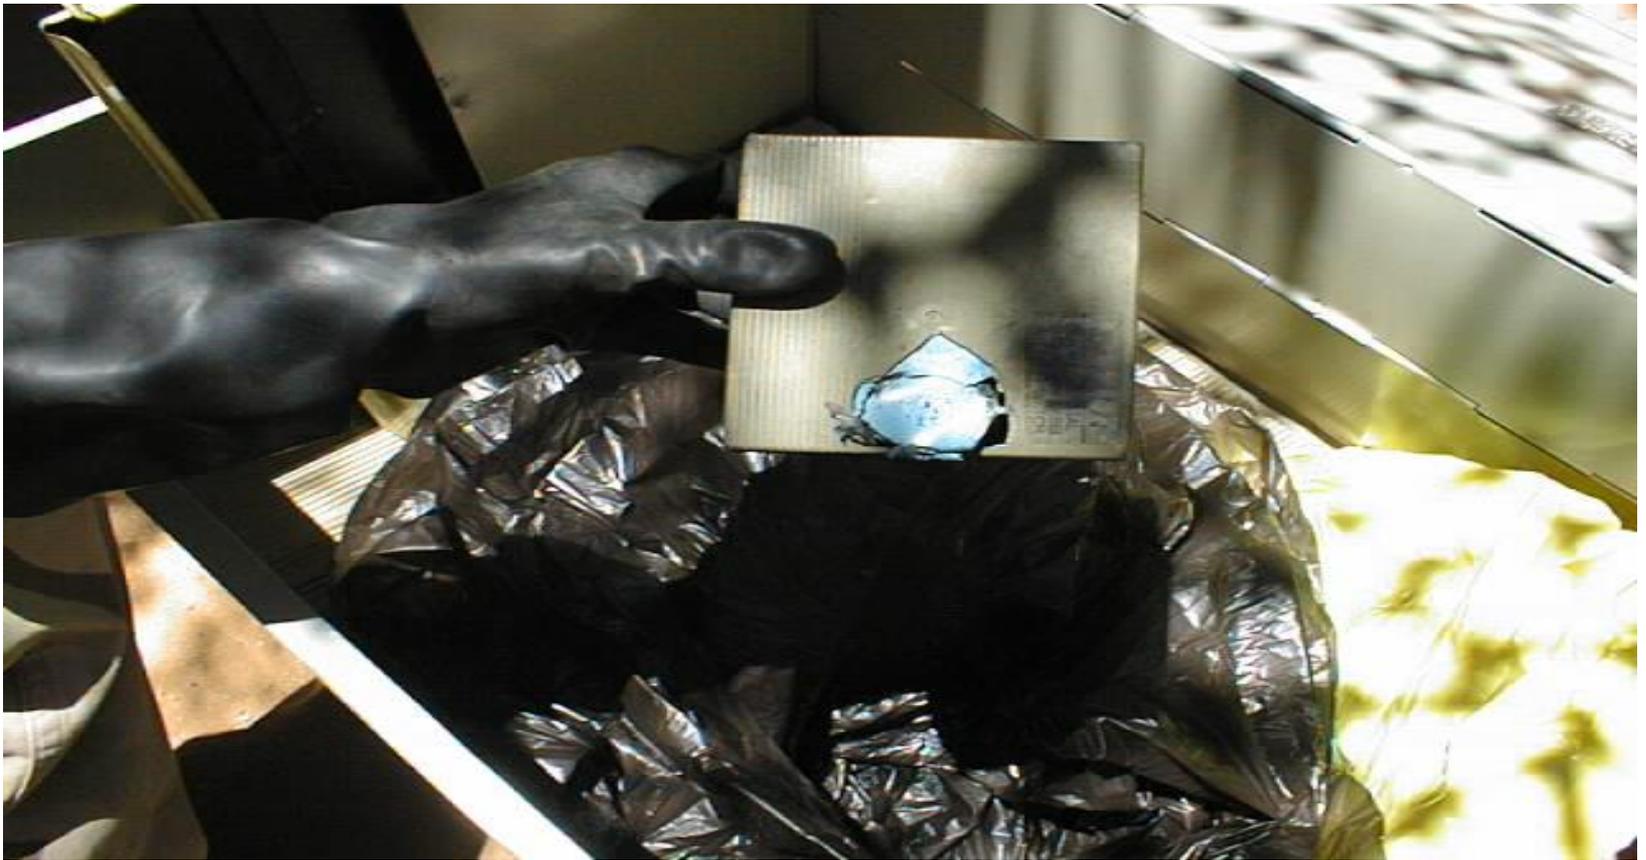
BA-5590/U, SAFT, Found in trash can

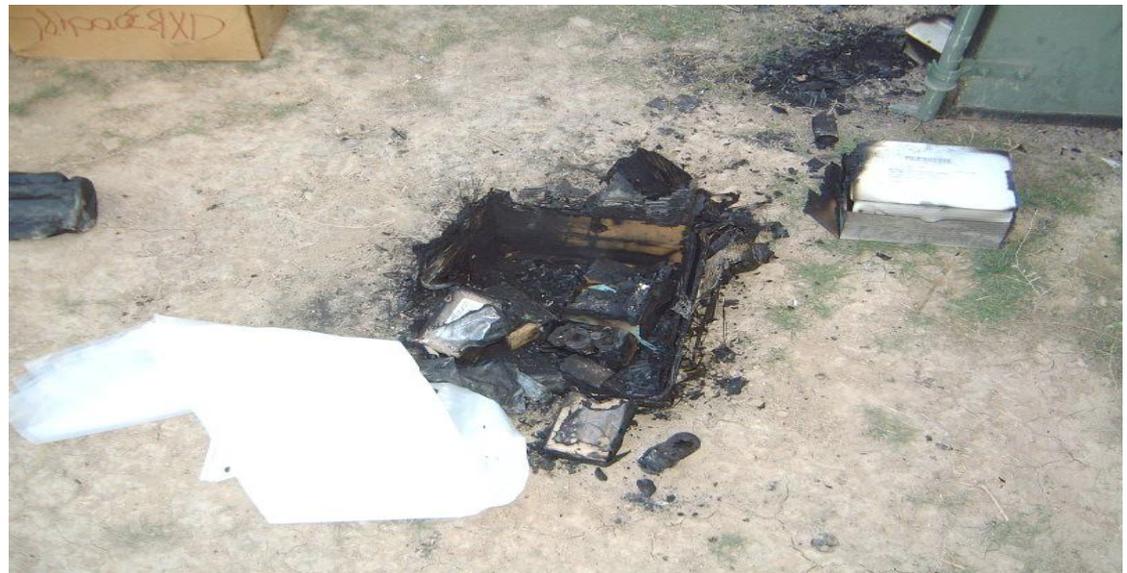
It's not just 10-cell batteries. A BA-5347/U. The burnt box below was in storage in a CONNEX container. The box was discovered inside the container after the fire had burned out. The location of the event was ***classified***; no investigation was possible.

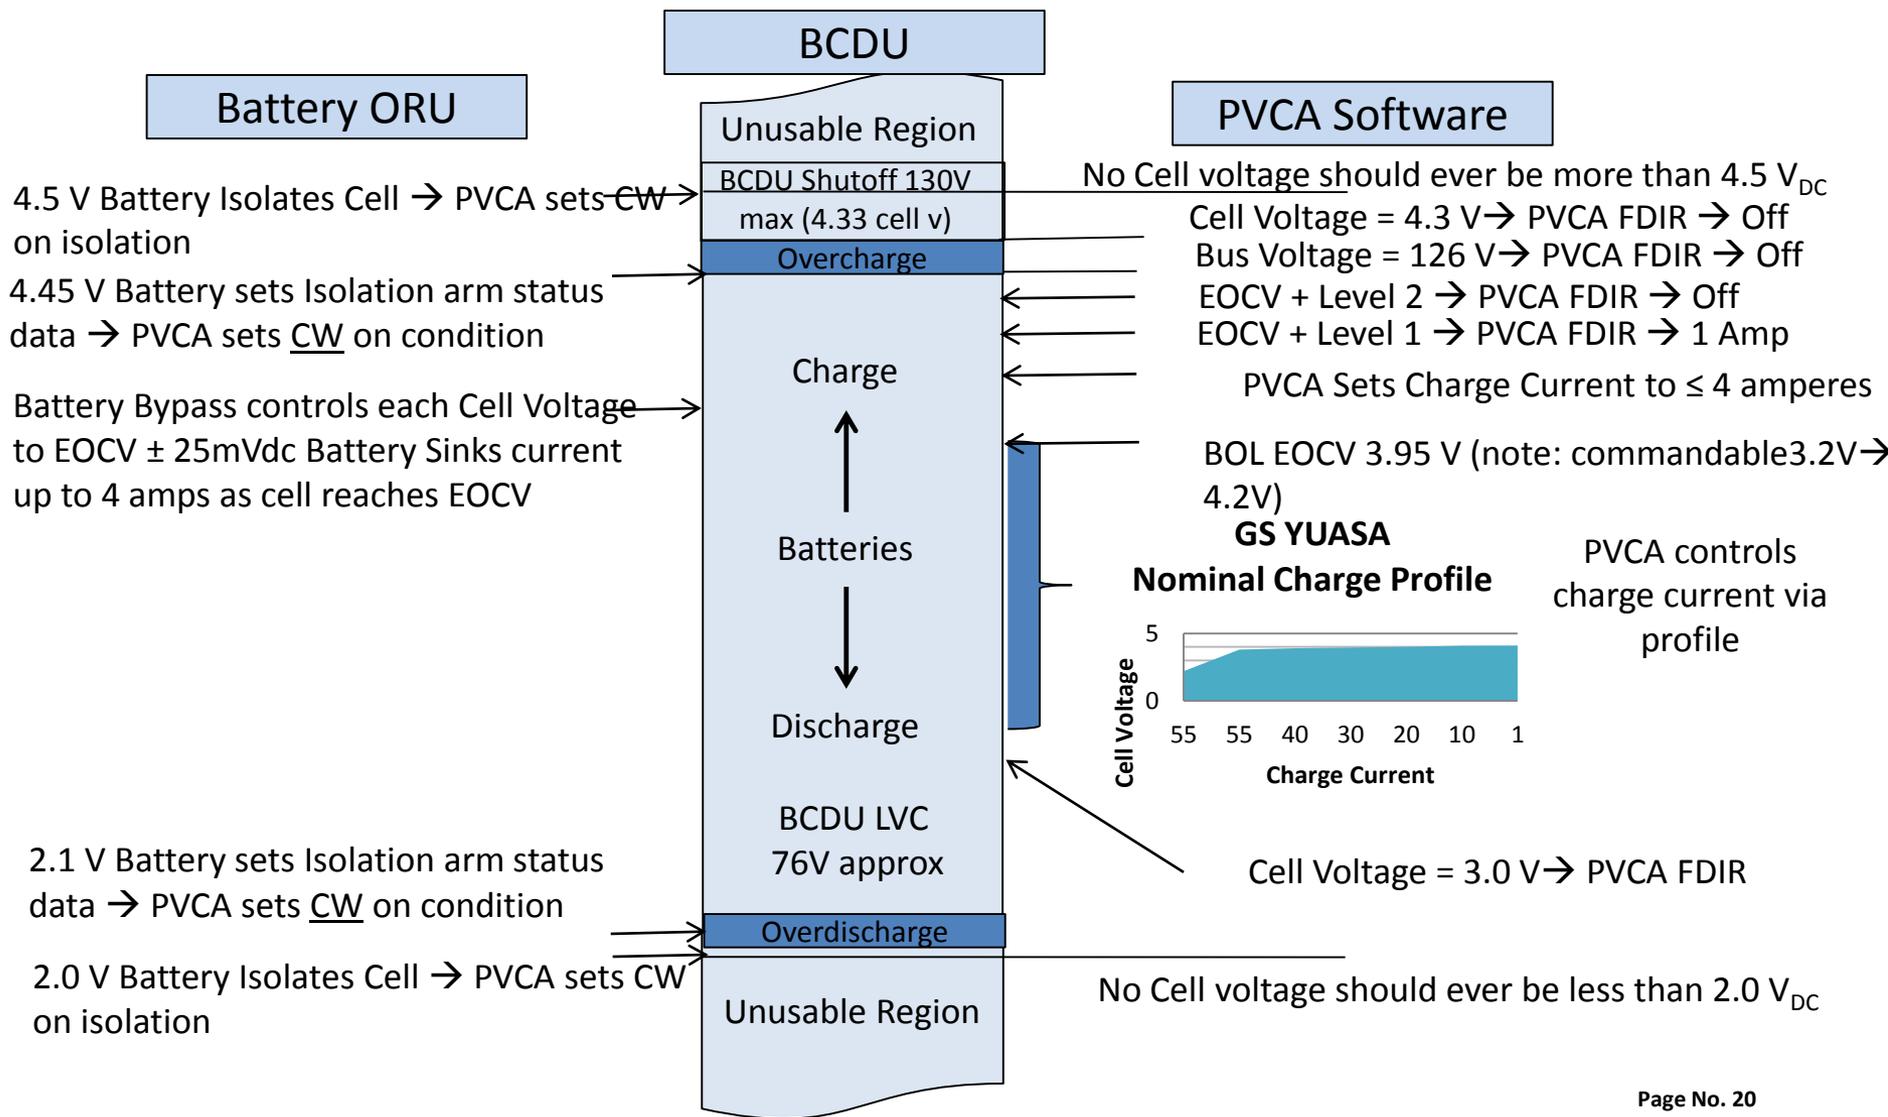
Safety Feature - Overcharge Control

- Over Charge / Over Discharge and Temperature Controls
 - 2 fault tolerant safety controls
 - Isolation of individuals cells prior to cell damage or thermal runaway thresholds (see backup)

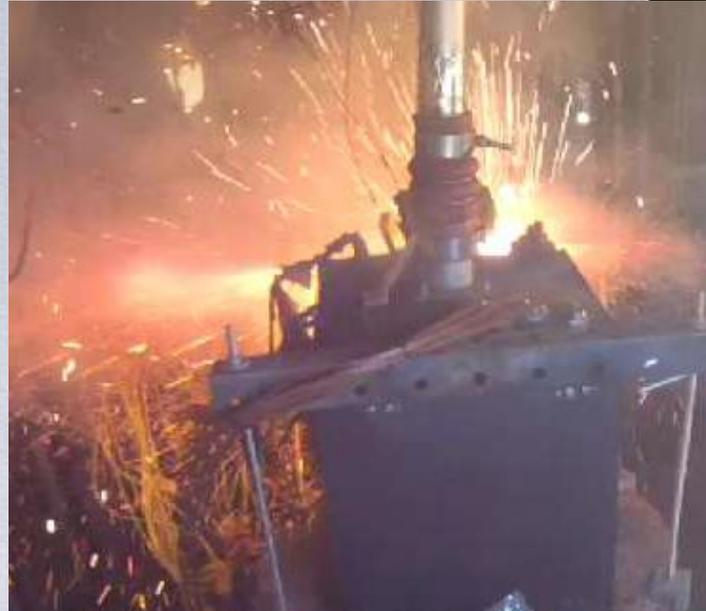
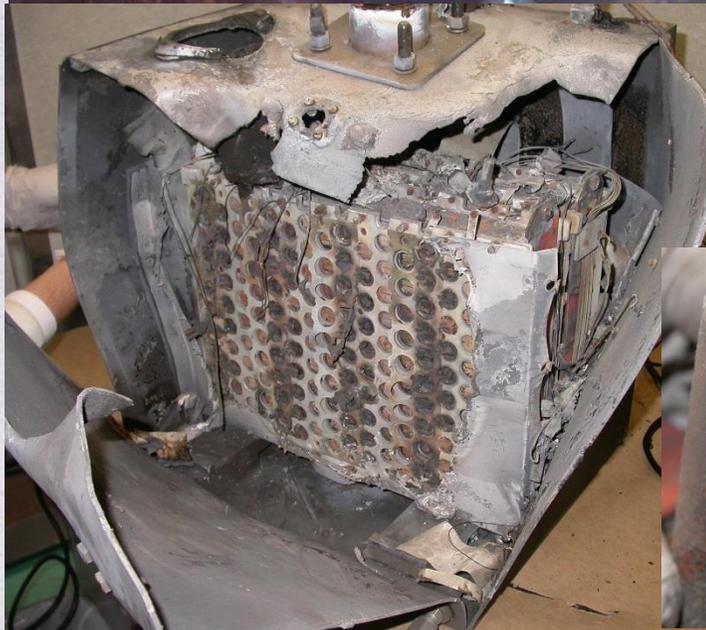
X-57 Battery Design Fails PPR Testing

- 320-cell module catastrophically fails during single cell PPR testing
 - Multiple cells propagated TR nearly simultaneously
 - DPA revealed numerous cell can side wall ruptures
- Design not following guidelines 1 and 2
 - Doesn't protect against sidewall rupture
 - Nomex paper (yellow) is weaved in between cell can walls
 - Cell secured at their ends with G10 capture plates maybe held too tightly
 - Doesn't provide sufficient heat dissipation between cells
 - Cell heat is dissipated through Ni bussing
 - Ni is a poor thermal conductor
- **Battery redesign and retest will require trigger cells with ISC device**

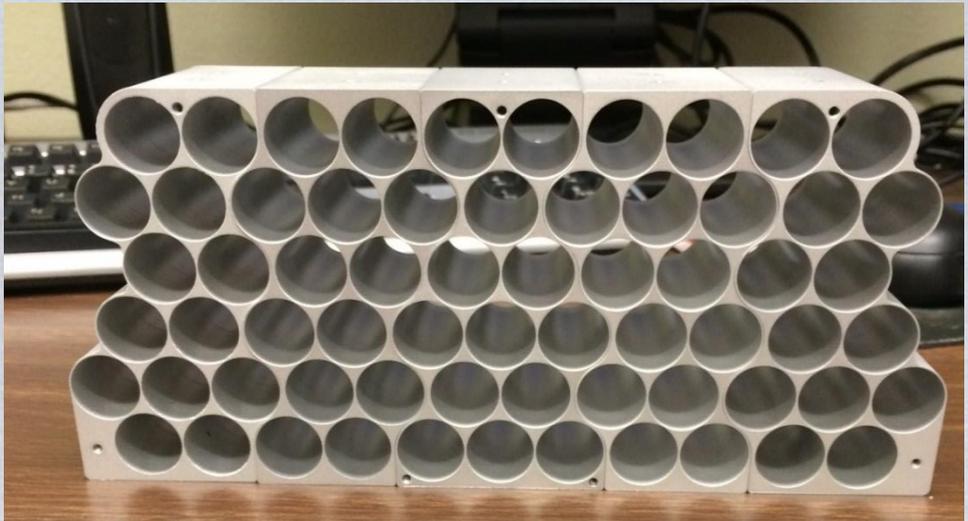
Safer, Higher Performing Spacesuit Battery Design

- 65 High Specific Energy Cell Design 3.4Ah (13P-5S)
- 37Ah and 686 Wh at BOL (in 16-20.5V window)
- Cell design likely to side wall rupture, but supported

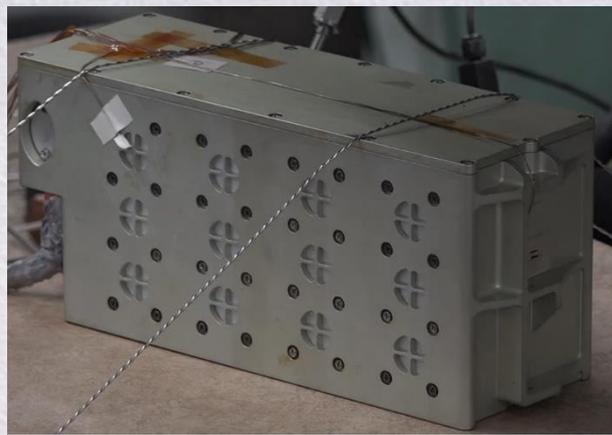
Full scale battery

- No corner cell locations

- **Minimize side wall ruptures**
 - Al interstitial heat sink
- **No direct cell-cell contact**
 - 0.5mm cell spacing, mica paper sleeves on each cell
- **Individually fusing cell in parallel**
 - 12A fusible link
- **Protecting adjacent cells from TR ejecta**
 - Ceramic bushing lining cell vent opening in G10 capture plate
- **Include flame arresting vent ports**
 - Tortious path with flame arresting screens
 - Battery vent ports lined with steel screens
