SYSTEM FAILURE CASE STUDY

June 2012 Volume 6 Issue 5

Balloon Mishap in the Outback

Nuclear Compton Telescope Balloon Mishap

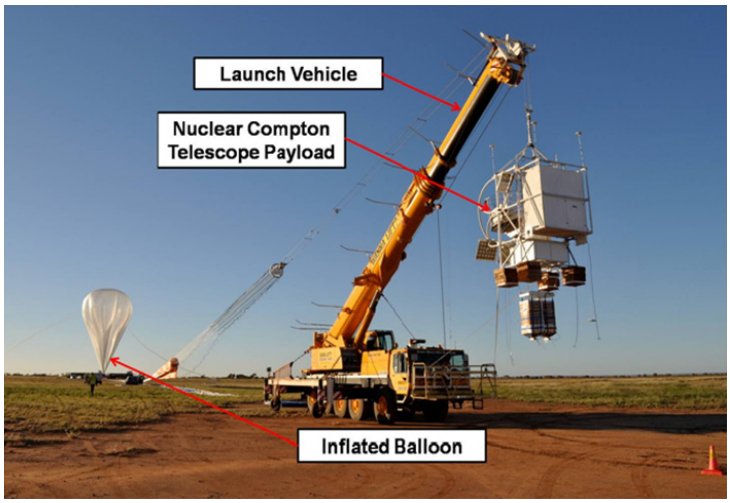
Figure 1: Launch configuration for the NCT during the day of the launch, preparing for release of balloon. Note the inflated balloon bubble.

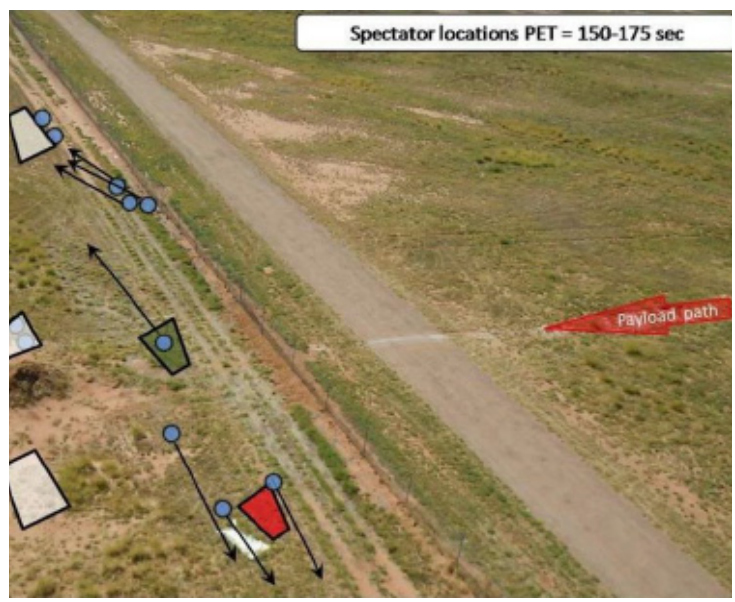
After the balloon bubble was inflated, but before spool release, the CSBF Launch Director noticed that some spectators had gathered downwind of the balloon's projected payload flight path (Figure 2). He requested that these spectators be moved. The UNSW SD responded and put out the request over the radio. An off-duty CSBF crew member, who was among the spectators, and the deputy UNSW SD heard the request.

The crew member, located south of the eventual flight path, moved spectators to the north while the deputy SD, located north of the eventual flight path, moved spectators south. This confusion and the final wind shift placed many spectators directly in the launch line.

Figure 2: Spectator locations (blue) in comparison with the payload path. Source: Mishap Investigation Board Report

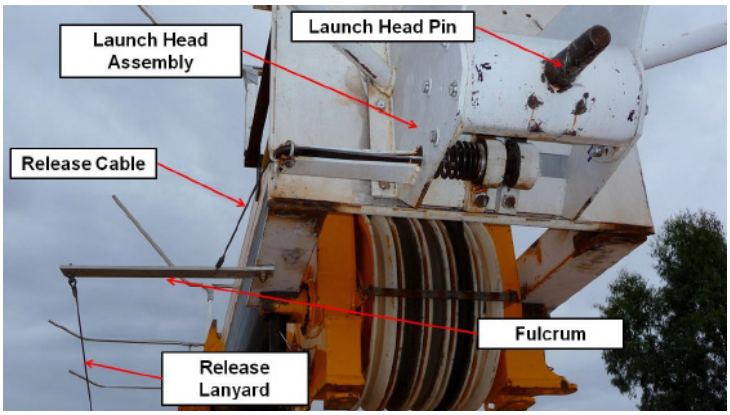
After the launch vehicle regained traction and repositioned, the Launch Director attempted to launch the balloon, but after pulling the lanyard to release the pin (Figure 3), the balloon failed to release.

The payload began to swing violently. The Launch Director attempted again to release the pin but was unable to do so. The balloon continued to travel downwind, and the Launch Director moved the launch vehicle again to catch up with the balloon for another launch attempt. Approximately 15 seconds later, the launch vehicle was forced to stop at the perimeter fence where the spectators were located.

Figure 3: The launch head assembly showing release lanyard and pin. The release lanyard must be activated manually.
