SYSTEM FAILURE CASE STUDIES

AUGUST 2010 *VOLUME 4 ISSUE 8*

Hit the Bricks

Launch of STS-124 damages launch pad: Repairs estimated at $2.5 million

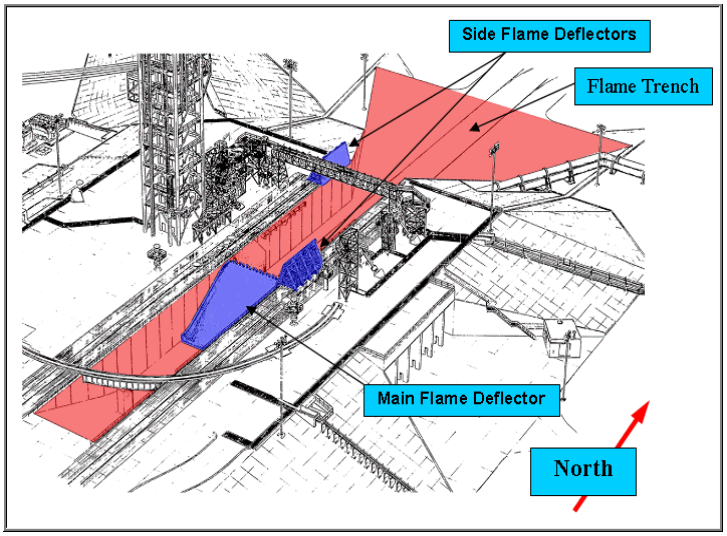
Figure 2: The flame trench is 450 feet long, 58 feet wide and 42 feet deep. The mouth of the trench extends to a width of 300 feet at the north end.

Forces from SRB ignition caused a section of the flame trench wall that had previously been repaired with Fondu Fyre to tear away, creating a fracture in the brick lining. Hot gas seeped through this fracture and built up between the concrete wall and the covering of refractory bricks. The bricks, secured only with aging epoxy and corroded anchors, gave way to the pressure of the hot gas and burst away from the concrete at the control joint (Figure 3). Since the bricks were installed with a tongue and groove mechanism, their interlocking design propagated a cascading effect that blasted the bricks varying distances, some exceeding 1,800 feet. The flying bricks, shown by radar to travel up to 680 miles per hour, damaged the west flame trench wall and a nearby perimeter fence. A total of approximately 3,540 refractory bricks in a 20 foot by 75 foot area ripped loose in the mishap. Repairs were estimated to cost $2.5 million.

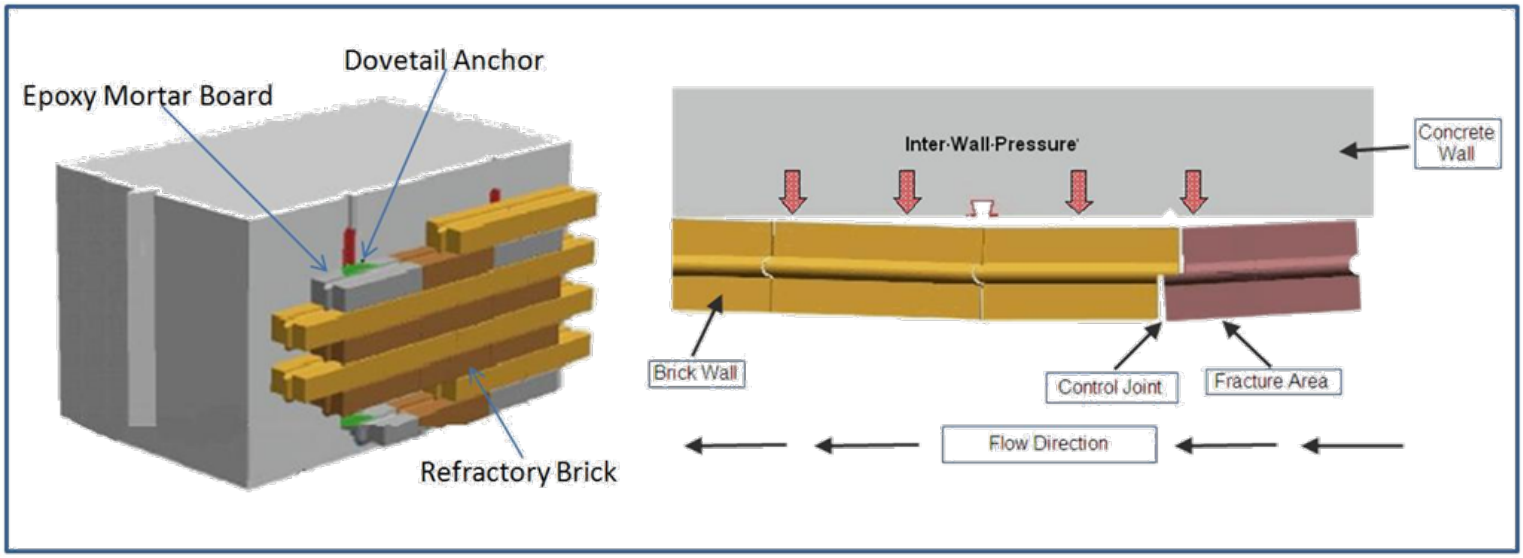
NASA investigators received full Shuttle program cooperation to access evidence. Completing a complex, challenging assignment in 30 days after the mishap, the investigation report described severe carbonation of the epoxy and extensive corrosion in the steel anchors. Because inspection teams lacked procedures and criteria that would have helped them detect this deterioration, the condition went unnoticed. Space Shuttle Discovery was then cleared for launch. During liftoff, the bricks were unable to withstand the pressure of the hot gas, which blew them away from the wall.

Figure 3: Cutaway depicting construction design of brick lining. The refractory bricks yielded to the pressure of the gas between the concrete wall and brick lining because carbonation of the epoxy reduced its adhesion and because repeated exposure to salt, water, and hydrochloric acid corroded the dovetail anchors.
