SYSTEM FAILURE CASE STUDIES

August 2011 *Volume 5 Issue 8*

Loss of Detection

Malfunctioning Train Control System in Washington D.C. Causes Deadly Crash

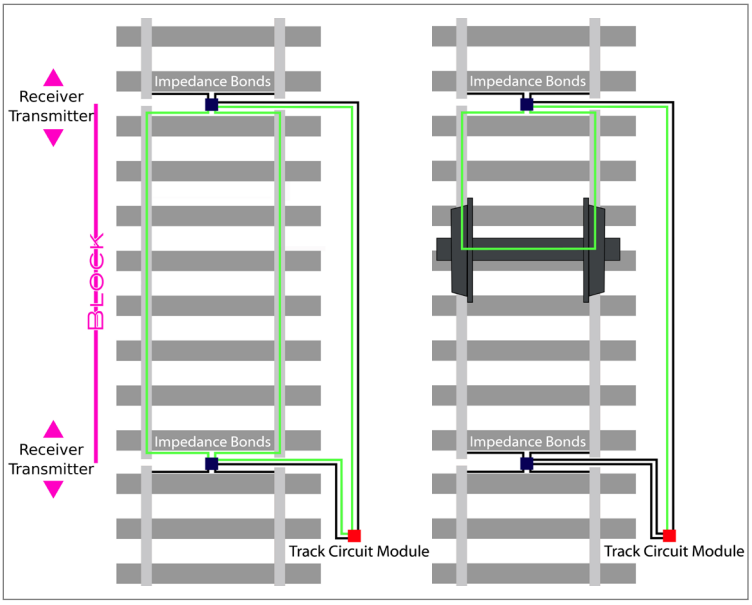
Figure 2: Each impedance bond acts as a transmitter for one track circuit and a receiver for the adjacent track circuit.
