SYSTEM FAILURE CASE STUDIES

November 2010 *Volume 4 Issue 11*

Spektr of Failure

Automated supply vehicle collides with Space Station *Mir*

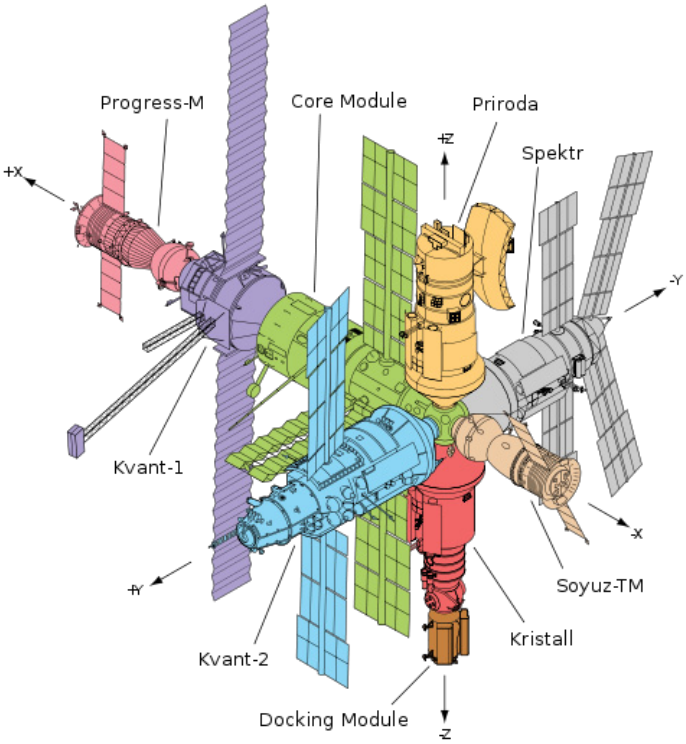
Ninety seconds remained before the final docking time when Lazutkin saw the Progress emerge suddenly, looming from behind one of *Mir*'s solar arrays. Urgently, he commanded Foale to flee to the *Soyuz* and prepare for evacuation. Suddenly learning of Progress' proximity, Tsibliyev clamped down the braking lever, but despite his commands, Progress coasted past the docking node over Base Block at high relative speed (three meters per second). *Mir*'s hull now filled Tsibliyev's entire screen. Then, Progress slammed into a solar array and ricocheted into the *Spektr* module, rocking the entire station (Figure 4). The crew felt the pressure change in their ears almost immediately and heard a loud hissing noise. Progress had punctured the hull somewhere on *Spektr*. If the crew did not act quickly, they would suffocate.

Figure 3: Core Module (Base Block) is shaded in green. Progress should have docked to Kvant-1. Instead, it collided with Spektr.

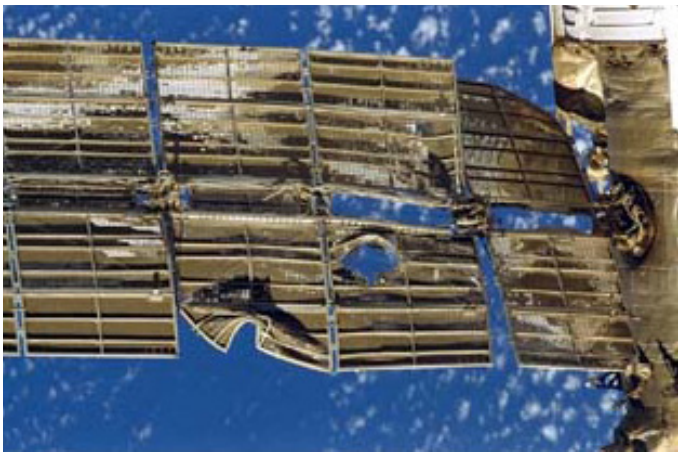
Figure 4: Mir solar array with collision-induced damage
