Spektr of Failure:

Mir-Progress Collision

Leadership ViTS Meeting

November 2010

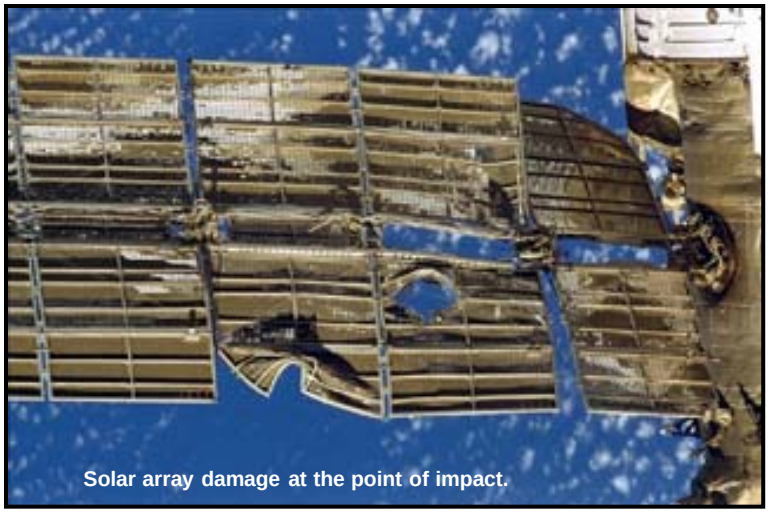
Solar array damage at the point of impact.

•Progress collided with a solar array, then ricocheted into *Spektr* module, where it punctured the hull and caused depressurization.
