System Failure Case Studies

Volume 1 Issue 3

ALMOST PERFECT

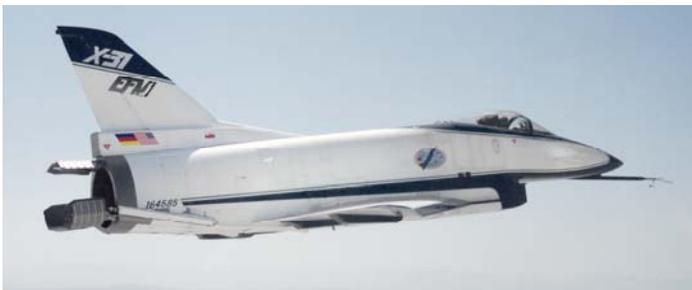
Three large, heat-resistant paddles on the rear of the X-31 were used to re-direct the engine exhaust and provide thrust-vectoring flight control. (Note the Pitot tube that is visible at the front of the aircraft.)

The Mishap Investigation Board found that "The [Pitot tube] icing led to incorrect total air pressure data being sent to the flight control computers (FCC) by the Pitot-static system. This resulted in the aircraft becoming unstable as it accelerated and descended to return for landing."
