## NASA Safety Center Special Study

APRIL 2009 SPECIAL STUDY: NASA CLOSE CALL

# Shuttle Software Anomaly

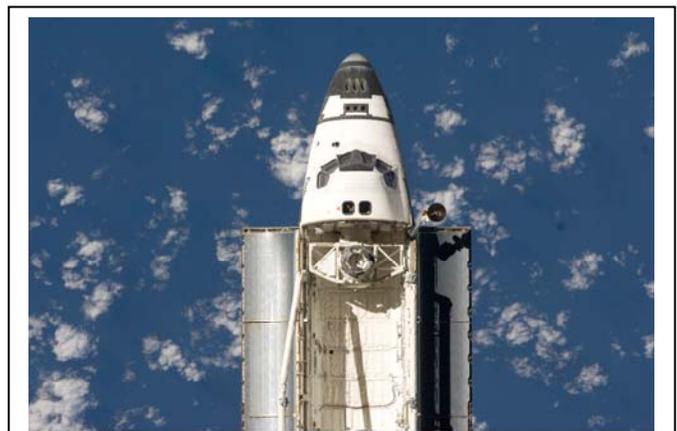
**Figure 1: Space Shuttle Endeavour preparing to dock with the International Space Station during STS-126. The round Ku-band antenna is visible to the right of the cockpit. The antenna is stowed in the payload bay until the shuttle reaches orbit.**

Shuttle operations that rely on radio frequencies for direct shuttle to ground communications during missions use S-band frequencies (1,700-2,300MHz) during launch, then switch to Ku-band communications (15,250-17250MHz) while in orbit. Once Ku-band communications are operational, the S-band remains as a fail-safe backup should the Ku-band lose signal.
